# Access Compliance Report Public Rights-of-Way (Curb Ramps)

Main Street: CECIL\_PASTURE\_RD Cross Street: CECIL\_PASTURE\_RD Location: S

ADA ID: RPRK211102124007 Ramp Type: Type 1 - Perpendicular Initial Pass/Fail: Pass Overall Compliance: No Severity Score: 5

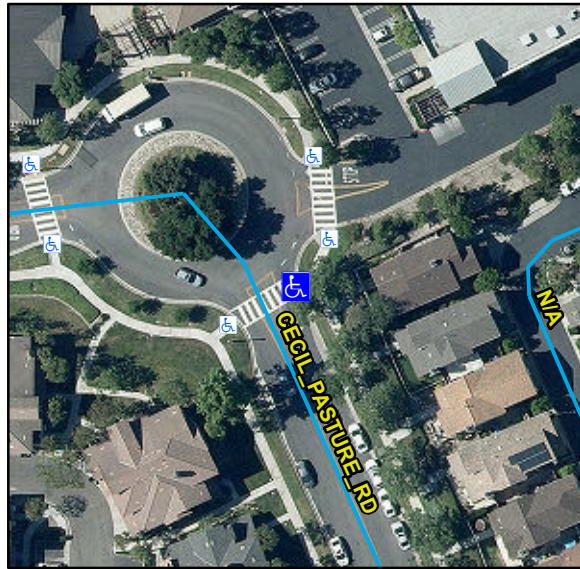
| Compliance | Description | Data | Compliance | Description | Data |
|---|---|---|---|---|---|
| Yes | Gutter Ponding | No | No | Curb Slope | 9.8 |
| No | Gutter Run Slope (%) | 6.1 | | Road Cross Slope (%) | N/A |

Remove & Replace Curb Slope. Remove & Replace Gutter.
