# Access Compliance Report Public Rights-of-Way (Curb Ramps)

Main Street: ST\_BRIDE\_WAY Cross Street: ST\_STEVEN\_CT Location: NW

ADA ID: RPRK211110133409 Ramp Type: Type 4 - Parallel Initial Pass/Fail: Pass Overall Compliance: No Severity Score: 25

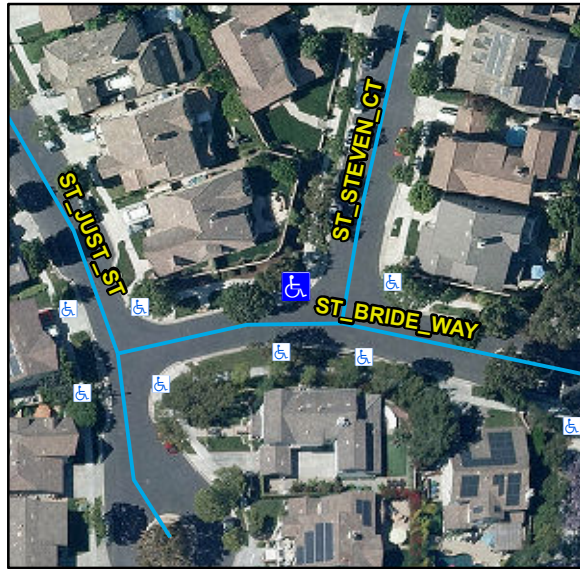
| Compliance | Description | Data | Compliance | Description | Data |
|---|---|---|---|---|---|
| N/A | Landing Present | No | No | DWS Provided | No |
| No | Landing Width (in) | N/A | N/A | DWS Length (in) | N/A |
| No | Landing Run Slope (%) | N/A | N/A | DWS Full Width | N/A |
| No | Landing Cross Slope (%) | N/A | | DWS Offset Type | N/A |
| No | Gutter Run Slope (%) | 6.6 | | Road Cross Slope (%) | 1.6 |
| No | Gutter Cross Slope (%) | 2.5 | No | Perpendicular Joint Present | No |

Remove & Replace Curb Ramp With Two New Directional Ramps or Equivalent. Remove & Replace Gutter.

R204.3, R304.2.1, R304.2.2-Perp, R304.3.2-Para, R304.5.3, R305, R304.5.4, STD 1115
