# Access Compliance Report Public Rights-of-Way (Curb Ramps)

Main Street: CLYDESDALE\_DR Cross Street: ABYSSINIAN\_WAY Location: NE

ADA ID: RPRK211110134430 Ramp Type: Type 4 - Parallel Initial Pass/Fail: Fail Overall Compliance: No Severity Score: 2

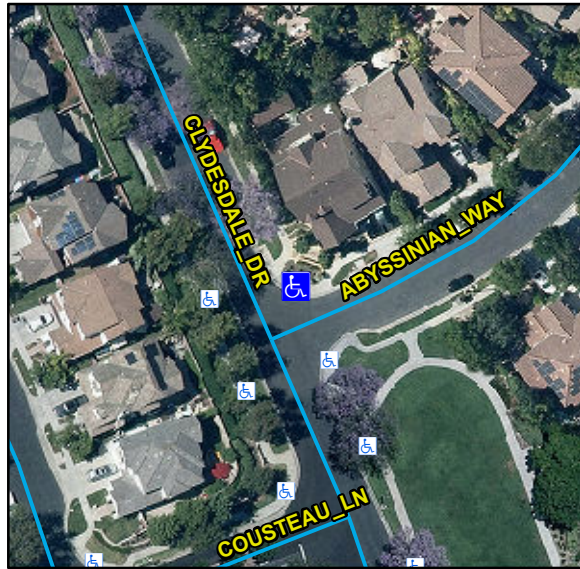
| Compliance | Description | Data | Compliance | Description | Data |
|---|---|---|---|---|---|
| No | Ramp Cross Slope LT (%) | 2.7 | No | Ramp Cross Slope RT (%) | 3.6 |

Remove & Replace Curb Ramp With Two New Directional Ramps or Equivalent.

R204.3, R304.5.3, STD 1115
