# Access Compliance Report Public Rights-of-Way (Curb Ramps)

Main Street: COUSTEAU\_LN Cross Street: LA\_SALLE\_LN Location: NW

ADA ID: RPRK211110135717 Ramp Type: Type 4 - Parallel Initial Pass/Fail: Fail Overall Compliance: No Severity Score: 16

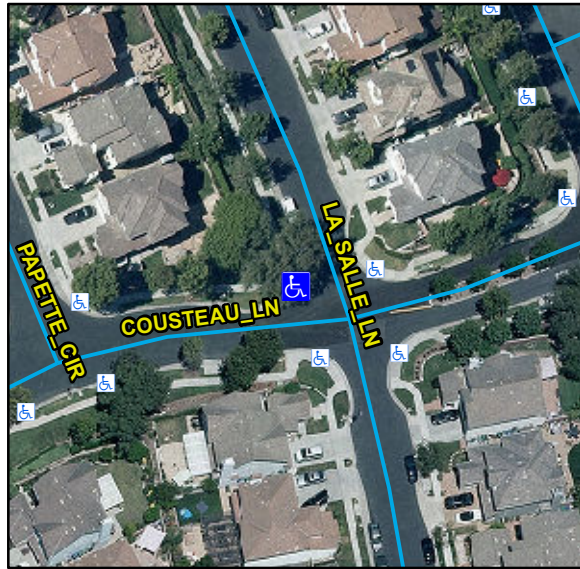
| Compliance | Description | Data | Compliance | Description | Data |
|---|---|---|---|---|---|
| No | Ramp Run Slope LT (%) | 9.1 | Yes | Ramp Run Slope RT (%) | 1.6 |
| No | Ramp Cross Slope LT (%) | 3.3 | No | Ramp Cross Slope RT (%) | 2.3 |

Remove & Replace Curb Ramp With Two New Directional Ramps or Equivalent.

R204.3, R304.3.2, R304.5.3, STD 1115
