# Access Compliance Report Public Rights-of-Way (Curb Ramps)

Main Street: COUSTEAU\_LN Cross Street: LA\_SALLE\_LN Location: SE

ADA ID: RPRK211110141133 Ramp Type: Type 4 - Parallel Initial Pass/Fail: Fail Overall Compliance: No Severity Score: 30

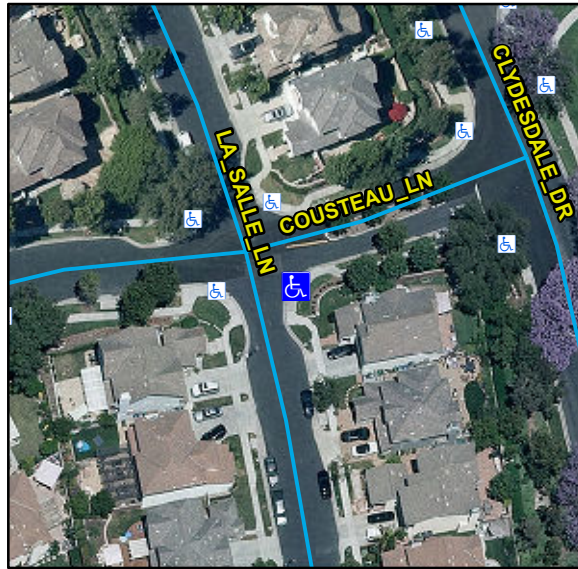
| Compliance | Description | Data | Compliance | Description | Data |
|---|---|---|---|---|---|
| Yes | Ramp Run Slope LT (%) | 2.1 | No | Ramp Run Slope RT (%) | 11.5 |
| No | Ramp Cross Slope LT (%) | 6.5 | Yes | Ramp Cross Slope RT (%) | 0.6 |

Remove & Replace Curb Ramp With Two New Directional Ramps or Equivalent.

R204.3, R304.5.3, R304.3.2, STD 1115
