# Access Compliance Report Public Rights-of-Way (Curb Ramps)

| Main Street: SIENNA_PKWY | | Cross Street: O_NEILL_DR | | Location: | NE |
| ADA ID: RPRK211111130121 | Ramp Type: Type 1 - Perpendicular | Initial Pass/Fail: Pass | Overall Compliance: No | Severity Score: | 0 |

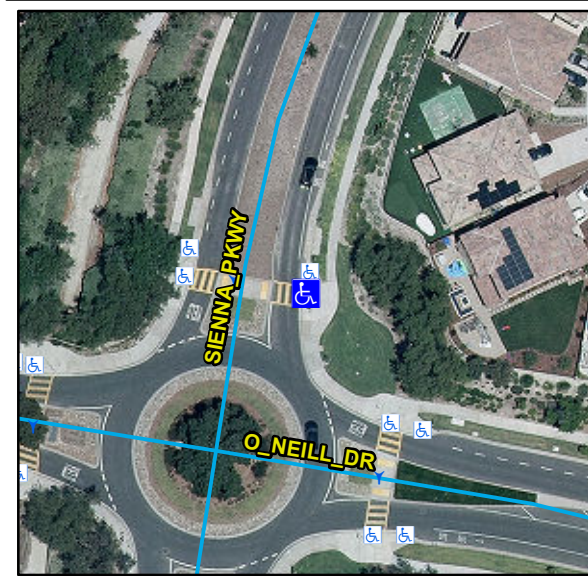
R304.2.2, R304.2.3, STD 1115

| Compliance | Description | Data | Compliance | Description | Data |
|---|---|---|---|---|---|
| N/A | Ramp Length (in) | 88 | No | Flare Type LT | Curbed1 |
| Yes | Gutter Ponding | No | No | Curb Slope | 6.8 |

Possible Solutions:

Remove & Replace Entire Ramp.

Total Cost: \$ 3080
