# Access Compliance Report Public Rights-of-Way (Curb Ramps)

Main Street: HANOVERIAN\_WAY Cross Street: FALABELLA\_DR Location: NE

ADA ID: RPRK211112150939 Ramp Type: Type 4 - Parallel Initial Pass/Fail: Fail Overall Compliance: No Severity Score: 2

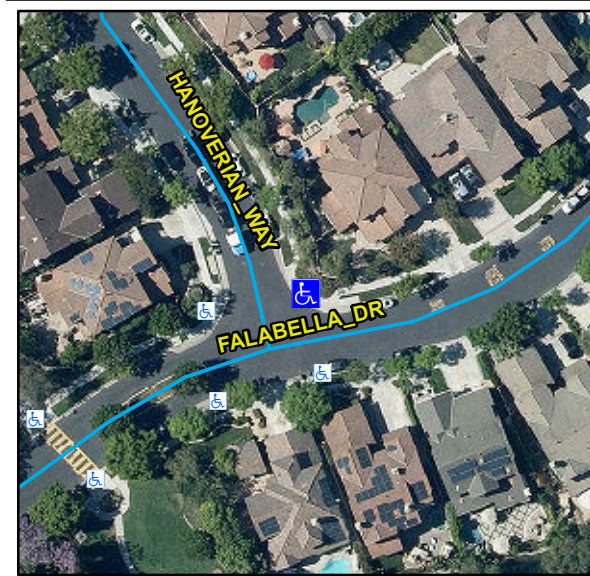
| Compliance | Description | Data | Compliance | Description | Data |
|---|---|---|---|---|---|
| No | Ramp Cross Slope LT (%) | 2.9 | Yes | Ramp Cross Slope RT (%) | 1.6 |

Remove & Replace Curb Ramp With Two New Directional Ramps or Equivalent.

R204.3, R304.5.3, STD 1115
