# Access Compliance Report Public Rights-of-Way (Curb Ramps)

Main Street: ROYCROFT\_CT Cross Street: BAINBRIDGE\_AVE Location: SW

ADA ID: RPRK211115120705 Ramp Type: Type 4 - Parallel Initial Pass/Fail: Pass Overall Compliance: No Severity Score: 26

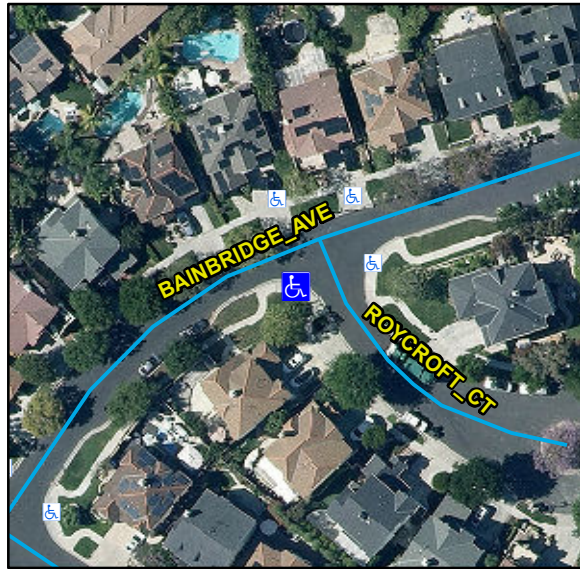
| Compliance | Description | Data | Compliance | Description | Data |
|---|---|---|---|---|---|
| No | Ramp Cross Slope LT (%) | 2.9 | No | Ramp Cross Slope RT (%) | 2.2 |
| No | Gutter Run Slope (%) | 8.8 | | Road Cross Slope (%) | 3.4 |

Remove & Replace Curb Ramp With Two New Directional Ramps or Equivalent. Remove & Replace Gutter.

R204.3, R304.5.3, R304.2.1, R304.2.2-Perp, R304.3.2-Para, R305, R304.5.4, STD 1115
