# Access Compliance Report Public Rights-of-Way (Curb Ramps)

Main Street: SIENNA\_PKWY Cross Street: ETHEREAL\_RD Location: E

ADA ID: RPRK211115122743 Ramp Type: Type 4 - Parallel Initial Pass/Fail: Pass Overall Compliance: No Severity Score: 19

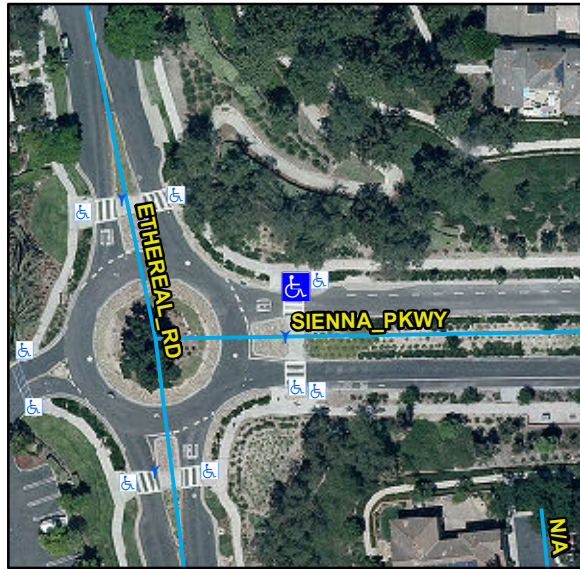
| Compliance | Description | Data | Compliance | Description | Data |
|---|---|---|---|---|---|
| No | Landing Width (in) | 47 | N/A | DWS Length (in) | N/A |
| Yes | Gutter Ponding | No | No | Curb Slope | 14.6 |
| No | Gutter Run Slope (%) | 11.4 | | Road Cross Slope (%) | N/A |

Remove & Replace Entire Ramp. Remove & Replace Gutter.
