# Access Compliance Report Public Rights-of-Way (Curb Ramps)

Main Street: SIENNA\_PKWY Cross Street: ETHEREAL\_RD Location: E

ADA ID: RPRK211115123018 Ramp Type: Type 4 - Parallel Initial Pass/Fail: Pass Overall Compliance: No Severity Score: 15

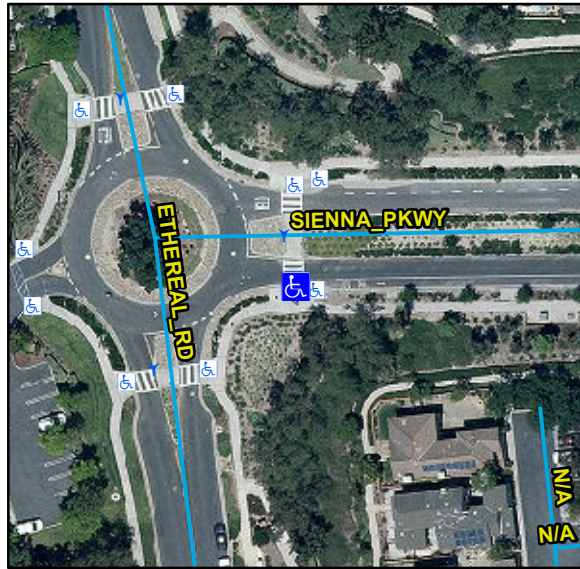
| Compliance | Description | Data | Compliance | Description | Data |
|---|---|---|---|---|---|
| N/A | Landing Present | Yes | No | DWS Provided | No |
| Yes | Gutter Ponding | No | No | Curb Slope | 18.7 |
| No | Gutter Run Slope (%) | 9.6 | | Road Cross Slope (%) | N/A |

Remove & Replace Entire Ramp. Remove & Replace Gutter.

R304.2.2, R304.2.1, R305, R304.5.4, STD 1115
