# Access Compliance Report Public Rights-of-Way (Curb Ramps)

| Main Street: ASCENSO_AVE | | Cross Street: ALZA_ST | | Location: | NE |
| ADA ID: RPRK211117131333 | Ramp Type: Type 4 - Parallel | Initial Pass/Fail: Fail | Overall Compliance: No | Severity Score: | 30 |

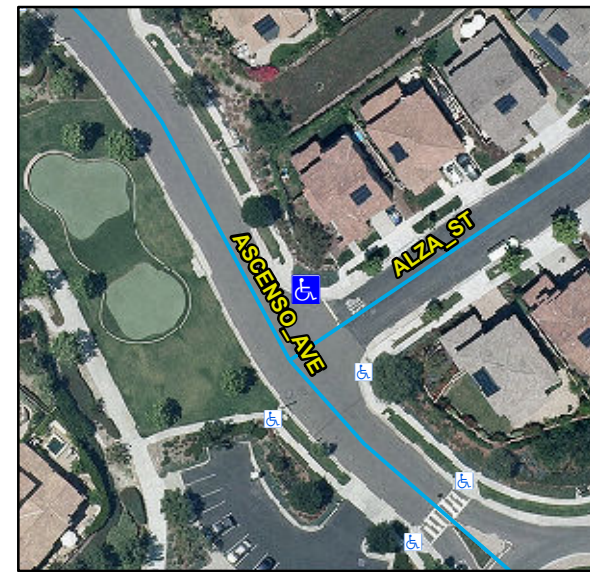
| Compliance | Description | Data | Compliance | Description | Data |
|---|---|---|---|---|---|
| No | Ramp Run Slope LT (%) | 13 | Yes | Ramp Run Slope RT (%) | 1.9 |

Possible Solutions:

**Remove & Replace Curb Ramp With Two New Directional Ramps or Equivalent.**

**R304.3.2, STD 1115**
