# Access Compliance Report Public Rights-of-Way (Curb Ramps)

| Main Street: CIELO_ST | | Cross Street: ASCENSO_AVE | | Location: | SE |
| ADA ID: RPRK211117132054 | Ramp Type: Type 4 - Parallel | Initial Pass/Fail: Fail | Overall Compliance: No | Severity Score: | 30 |

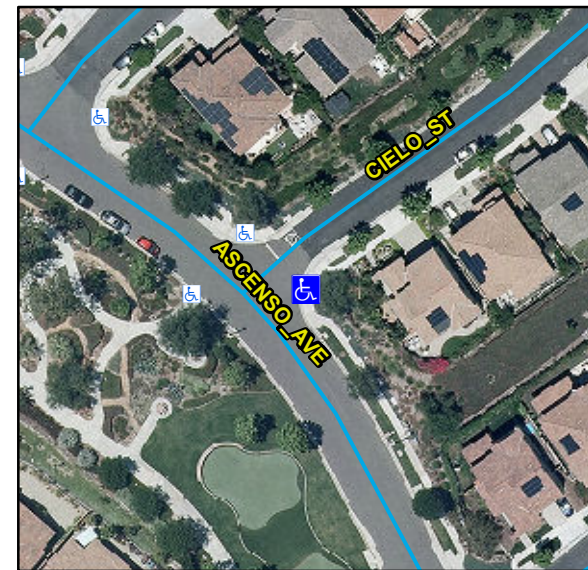
| Compliance | Description | Data | Compliance | Description | Data |
|---|---|---|---|---|---|
| No | Ramp Run Slope LT (%) | 13.1 | Yes | Ramp Run Slope RT (%) | 3.5 |

**Remove & Replace Curb Ramp With Two New Directional Ramps or Equivalent.**

**R304.3.2, STD 1115**
