# Access Compliance Report Public Rights-of-Way (Curb Ramps)

| Main Street: ASCENSO_AVE | | Cross Street: ASCENSO_AVE | | Location: | NW |
| ADA ID: RPRK211117133106 | Ramp Type:Type 1 - Perpendicular | Initial Pass/Fail: Pass | Overall Compliance: No | Severity Score: | 5 |

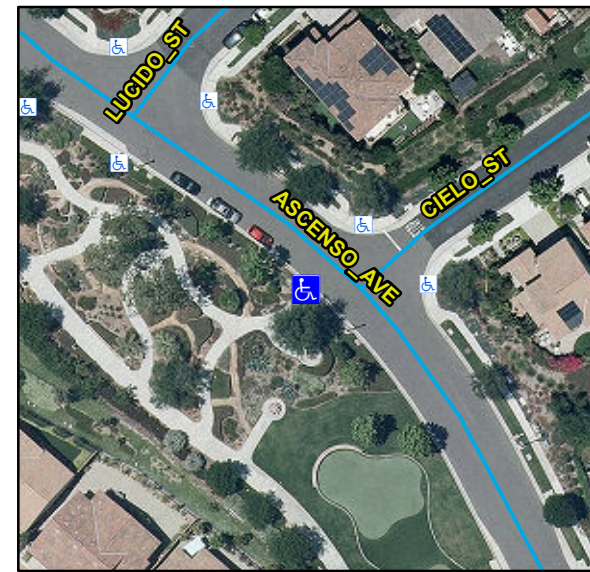
| Compliance | Description | Data | Compliance | Description | Data |
|---|---|---|---|---|---|
| Yes | Gutter Ponding | No | No | Curb Slope | 7.1 |
| No | Gutter Run Slope (%) | 12.5 | | Road Cross Slope (%) | N/A |
| No | Gutter Cross Slope (%) | 6.6 | | | |

**Remove & Replace Curb Slope. Remove & Replace Gutter.**

**R304.2.2, R304.5.4, R304.5.3, STD 1115**
