# Access Compliance Report Public Rights-of-Way (Curb Ramps)

Main Street: LUCIDO\_ST Cross Street: ASCENSO\_AVE Location: E

ADA ID: RPRK211117133608 Ramp Type: Type 4 - Parallel Initial Pass/Fail: Fail Overall Compliance: No Severity Score: 16

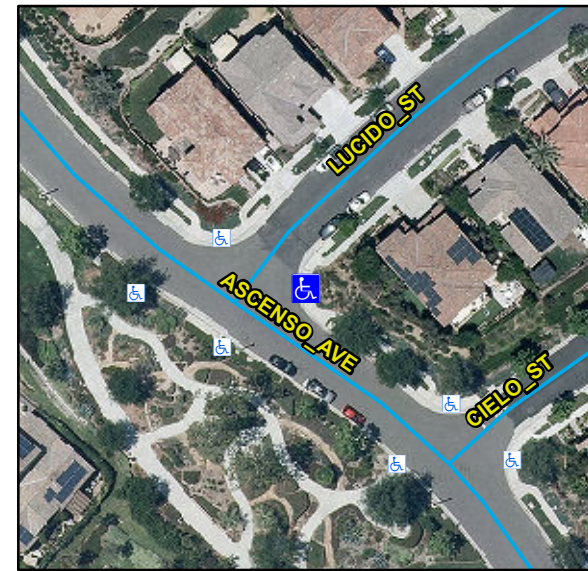
| Compliance | Description | Data | Compliance | Description | Data |
|---|---|---|---|---|---|
| No | Ramp Run Slope LT (%) | 10.5 | Yes | Ramp Run Slope RT (%) | 0.5 |
| Yes | Ramp Cross Slope LT (%) | 0.2 | No | Ramp Cross Slope RT (%) | 2.2 |

Remove & Replace Curb Ramp With Two New Directional Ramps or Equivalent.

R304.3.2, R304.5.3, STD 1115

Total Cost: \$ 4000
