# Access Compliance Report Public Rights-of-Way (Curb Ramps)

Main Street: ASCENSO\_AVE Cross Street: SENDERO\_WAY Location: S

ADA ID: RPRK211117152423 Ramp Type: Type 1 - Perpendicular Initial Pass/Fail: Pass Overall Compliance: Yes Severity Score: 0

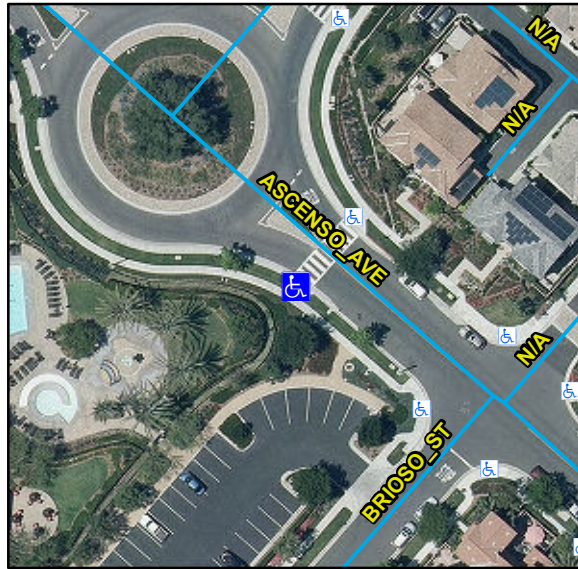
| Compliance | Description | Data | Compliance | Description | Data |
|---|---|---|---|---|---|
| N/A | Ramp Length (in) | 60 | N/A | Flare Type LT | |
| Yes | Ramp Width (in) | 60 | | | Sloped |
| Yes | Ramp Run Slope (%) | 8.3 | N/A | Flare Slope LT (%) | 9.4 |
| Yes | Ramp Cross Slope (%) | 0.8 | N/A | Flare Traversable LT | No |
| Yes | Overall Surface Condition: Acceptable | | Yes | Perp Joint Present | Yes |

N/A
