# Access Compliance Report Public Rights-of-Way (Curb Ramps)

| Main Street: SENDERO WAY | | Cross Street: ASCENSO AVE | | Location: | E |
| ADA ID: RPRK211117152809 | Ramp Type: Type 1 - Perpendicular | Initial Pass/Fail: Pass | Overall Compliance: No | Severity Score: | 6 |

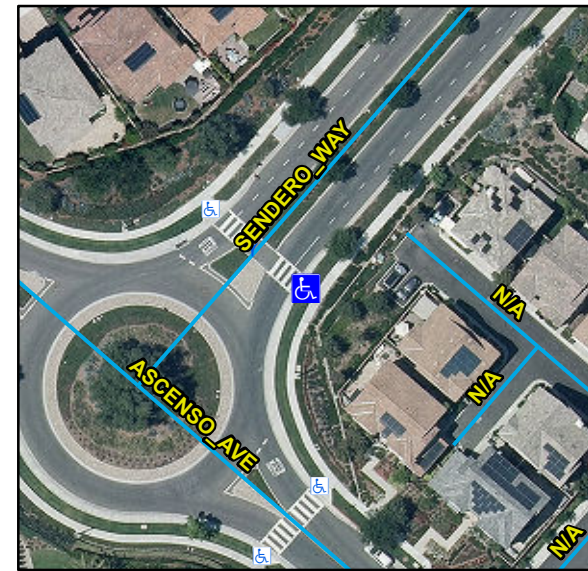
| Compliance | Description | Data | Compliance | Description | Data |
|---|---|---|---|---|---|
| No | Landing Run Slope (%) | 2.6 | N/A | Flare Traversable RT | No |
| No | Gutter Run Slope (%) | 5.5 | | Road Cross Slope (%) | N/A |
| No | Gutter Cross Slope (%) | 2.3 | | | |

**Remove & Replace Landing. Remove & Replace Gutter.**
