# Access Compliance Report Public Rights-of-Way (Curb Ramps)

| Main Street: ASCENSO_AVE | | Cross Street: BRIOSO_ST | | Location: | SW |
| ADA ID: RPRK211117154103 | Ramp Type: Type 4 - Parallel | Initial Pass/Fail: Pass | Overall Compliance: No | Severity Score: | 6 |

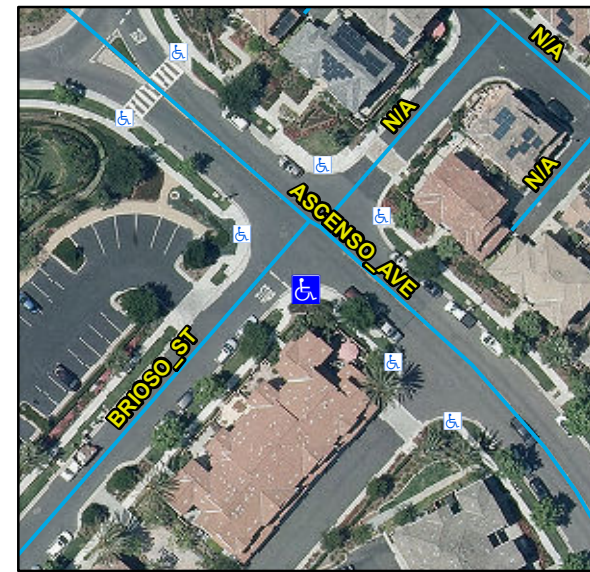
| Compliance | Description | Data | Compliance | Description | Data |
|---|---|---|---|---|---|
| No | Gutter Run Slope (%) | 8.6 | | Road Cross Slope (%) | 4.1 |

Possible Solutions:

Remove & Replace Gutter.

R304.5.4, STD 1115

Total Cost: \$ 252

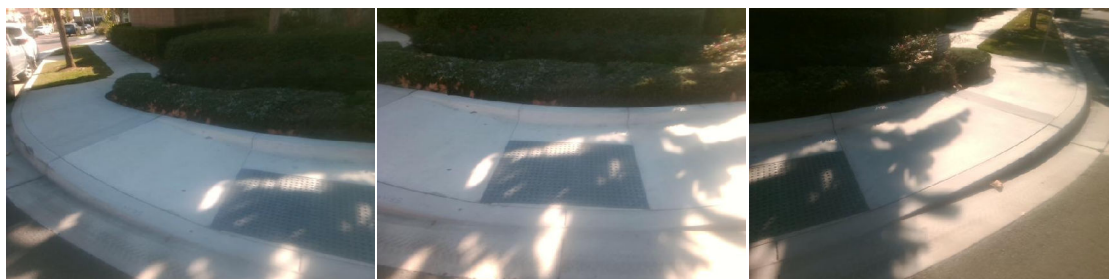
| Compliance | Description | Data | Compliance | Description | Data |
| N/A | Ramp Length LT (in) | 72 | N/A | Ramp Length RT (in) | 85 |
| Yes | Ramp Width LT (in) | 53 | Yes | Ramp Width RT (in) | 53 |
| Yes | Ramp Run Slope LT (%) | 6.1 | Yes | Ramp Run Slope RT (%) | 8.1 |
| Yes | Ramp Cross Slope LT (%) | 2 | Yes | Ramp Cross Slope RT (%) | 0 |
