# Access Compliance Report Public Rights-of-Way (Curb Ramps)

Main Street: FLOREAR\_RD Cross Street: FLOREAR\_RD Location: N

ADA ID: RPRK211117163159 Ramp Type: Type 4 - Parallel Initial Pass/Fail: Pass Overall Compliance: No Severity Score: 6

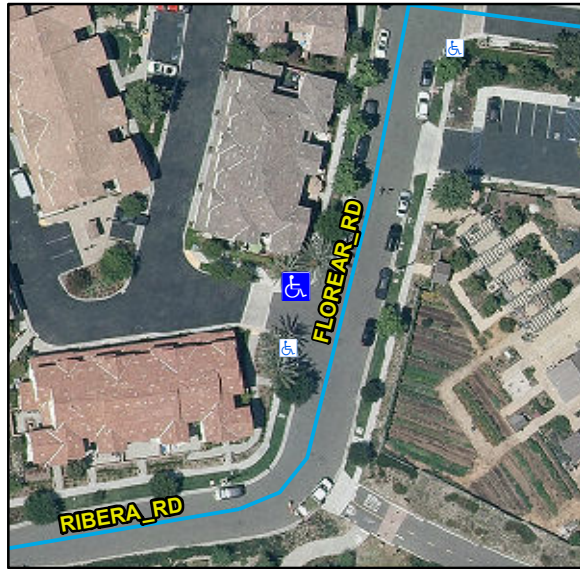
| Compliance | Description | Data | Compliance | Description | Data |
|---|---|---|---|---|---|
| No | Landing Cross Slope (%) | 4.5 | | DWS Offset Type | Single |
| No | Gutter Run Slope (%) | 9.9 | | Road Cross Slope (%) | 0.4 |
| No | Gutter Cross Slope (%) | 4.5 | Yes | Perpendicular Joint Present | Yes |

Remove & Replace Landing. Remove & Replace Gutter.

R304.5.3, R304.5.4, STD 1115
