# Access Compliance Report Public Rights-of-Way (Curb Ramps)

| Main Street: RIBERA_RD | | Cross Street: BRIOSO_ST | | Location: | NW |
| ADA ID: RPRK211118124831 | Ramp Type: Type 4 - Parallel | Initial Pass/Fail: Pass | Overall Compliance: Yes | Severity Score: | 0 |

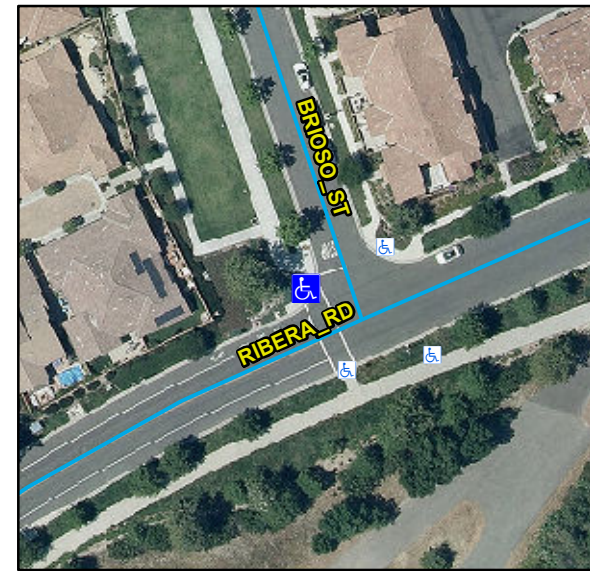
| Compliance | Description | Data | Compliance | Description | Data |
|---|---|---|---|---|---|
| N/A | Ramp Length LT (in) | 71 | N/A | Ramp Length RT (in) | 78 |
| Yes | Ramp Width LT (in) | 53 | Yes | Ramp Width RT (in) | 53 |
| Yes | Ramp Run Slope LT (%) | 7.3 | Yes | Ramp Run Slope RT (%) | 3.6 |
| Yes | Ramp Cross Slope LT (%) | 0.6 | Yes | Ramp Cross Slope RT (%) | 0.8 |
| Yes | Landing Width (in) | 48 | Yes | DWS Length (in) | 36 |
| Yes | Landing Run Slope (%) | 0.8 | Yes | DWS Full Width | Yes |
| Yes | Landing Cross Slope (%) | 0.8 | | DWS Offset Type | Single |

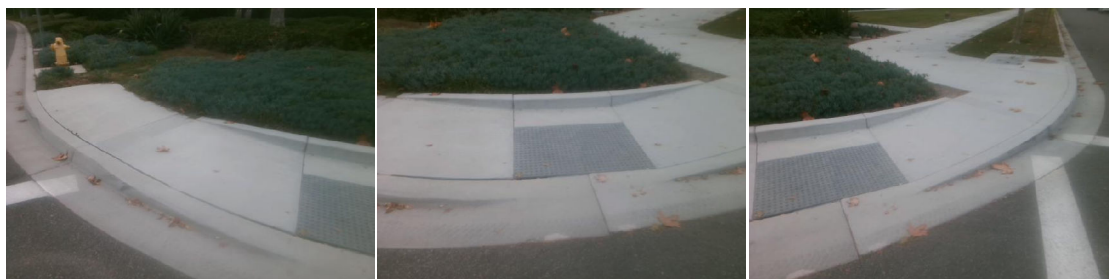
| Compliance | Description | Data | Compliance | Description | Data |
|---|---|---|---|---|---|
| Yes | Overall Surface Condition | Acceptable | | | |
