# Access Compliance Report Public Rights-of-Way (Curb Ramps)

Main Street: N/A Cross Street: SENDERO\_WAY Location: E

ADA ID: RPRK211122124642 Ramp Type: Type 6 - Directional 1 Initial Pass/Fail: Pass Overall Compliance: No Severity Score: 5

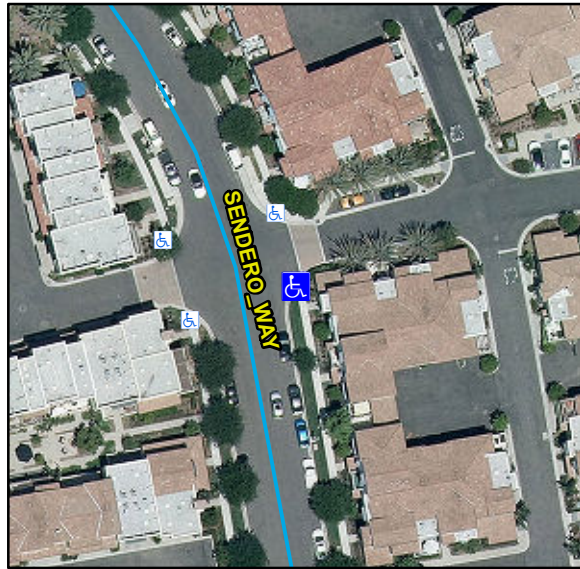
| Compliance | Description | Data | Compliance | Description | Data |
|---|---|---|---|---|---|
| No | Gutter Run Slope (%) | 9.8 | | Road Cross Slope (%) | N/A |

Possible Solutions:

Remove & Replace Gutter.

R304.5.4, STD 1115

Total Cost: \$ 252
