# Access Compliance Report Public Rights-of-Way (Curb Ramps)

Main Street: N/A Cross Street: ASCENSO\_AVE Location: W

ADA ID: RPRK211122131243 Ramp Type: Type 6 - Directional 1 Initial Pass/Fail: Pass Overall Compliance: No Severity Score: 0

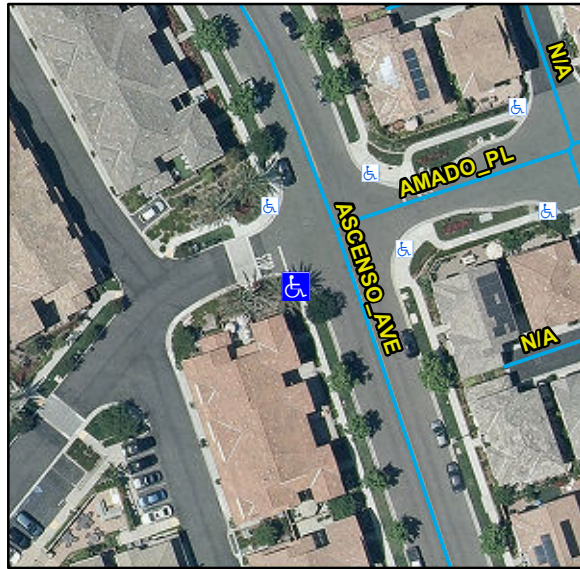
| Compliance | Description | Data | Compliance | Description | Data |
|---|---|---|---|---|---|
| No | Grade Break Cross Slope (%) | 2.9 | N/A | Flare Slope RT (%) | N/A |
| No | Gutter Cross Slope (%) | 2.1 | | Parallel Ramp Side | Right |

Remove & Replace Grade Break. Remove & Replace Gutter.

R304.5.3, STD 1115

Total Cost: \$ 783
