# Access Compliance Report Public Rights-of-Way (Curb Ramps)

Main Street: N/A Cross Street: AMADO\_PL Location: N

ADA ID: RPRK211122131758 Ramp Type: Type 6 - Directional 1 Initial Pass/Fail: Pass Overall Compliance: No Severity Score: 6

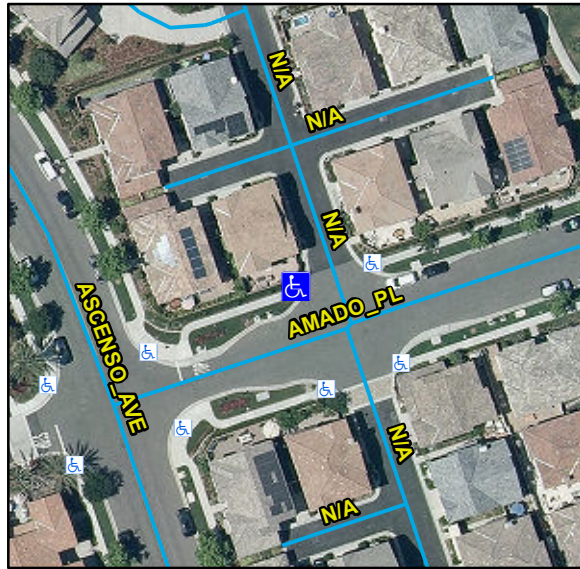
| Compliance | Description | Data | Compliance | Description | Data |
|---|---|---|---|---|---|
| No | Landing Length (in) | 44 | Yes | DWS Length (in) | 72 |
| No | Landing Cross Slope (%) | 2.2 | Yes | DWS Left Offset (in) | 0 |
| No | Gutter Cross Slope (%) | 2.1 | | Parallel Ramp Side | Right |

Remove & Replace Landing. Remove & Replace Gutter.

R304.2.1, R304.5.3, STD 1115
