# Access Compliance Report Public Rights-of-Way (Curb Ramps)

Main Street: N/A Cross Street: AMADO\_PL Location: N

ADA ID: RPRK211122132806 Ramp Type: Type 6 - Directional 1 Initial Pass/Fail: Pass Overall Compliance: No Severity Score: 0

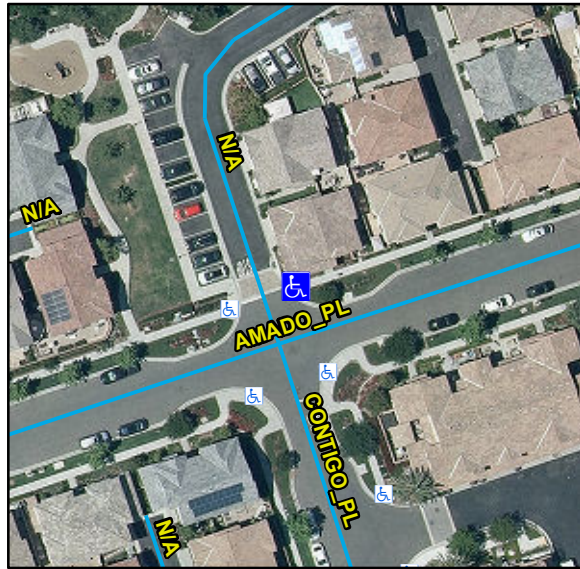
| Compliance | Description | Data | Compliance | Description | Data |
|---|---|---|---|---|---|
| No | Grade Break Slope (%) | 6.4 | | | Sloped |
| Yes | Gutter Ponding | No | No | Curb Slope | 8.9 |
| No | Gutter Cross Slope (%) | 2.4 | | Parallel Ramp Side | Left |

Remove & Replace Entire Ramp. Remove & Replace Gutter.
