Main Street: N/A Cross Street: FLOREAR\_RD Location: W

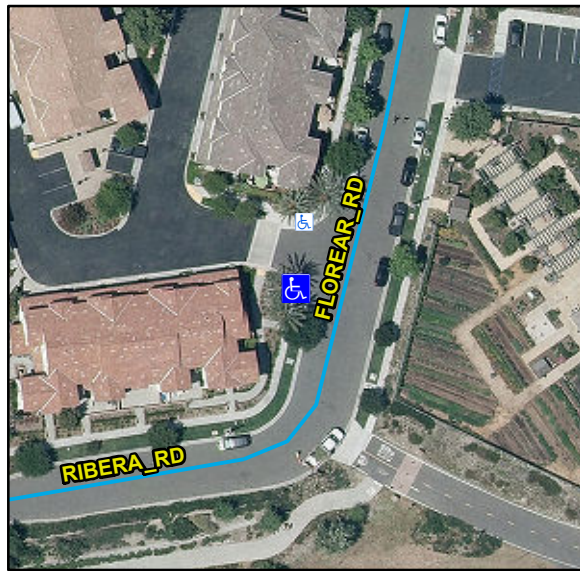
ADA ID: RPRK211122134555 Ramp Type: Type 6 - Directional 1 Initial Pass/Fail: Pass Overall Compliance: No Severity Score: 2

| Compliance | Description | Data | Compliance | Description | Data |
|---|---|---|---|---|---|
| No | Grade Break Cross Slope (%) | 3 | N/A | Flare Slope RT (%) | N/A |
| No | Gutter Cross Slope (%) | 2.2 | | Parallel Ramp Side | Right |

Remove & Replace Grade Break. Remove & Replace Gutter.

R304.5.3, STD 1115

Total Cost: \$ 783
