# Access Compliance Report Public Rights-of-Way (Curb Ramps)

Main Street: CHIQUITA\_CANYON\_DR Cross Street: LOS\_PATRONES\_PKWY Location: SW

ADA ID: RPRK211130120304 Ramp Type: Type 4 - Parallel Initial Pass/Fail: Pass Overall Compliance: No Severity Score: 0

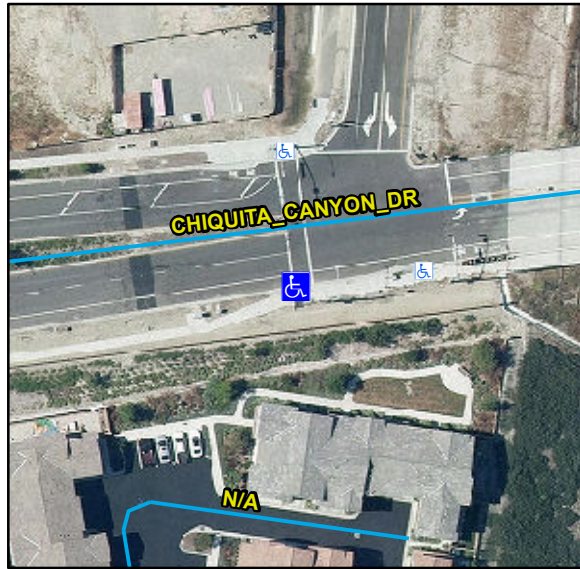
| Compliance | Description | Data | Compliance | Description | Data |
|---|---|---|---|---|---|
| No | Ramp Inside Crosswalk 1 | No | N/A | Ramp Inside Crosswalk 2 | N/A |
| Yes | Gutter Ponding | No | No | Curb Slope | 8.9 |

Remove & Replace Curb Slope. Restripe Crosswalk.

R304.2.2, R207.1, STD 1115
