Access Compliance Report Public Rights-of-Way (Curb Ramps)

Main Street: ESENCIA_DR **Cross Street: AIROSO ST** Location: ADA ID: RPRK211201131654 Ramp Type: Type 4 - Parallel **Initial Pass/Fail: Pass Overall Compliance: Yes Severity Score:**

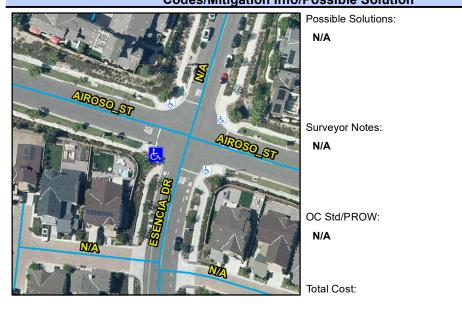
Field Measurements/Component Compliance										
	Com	Compliance Description		Com	pliance Description	Data				
	N/A	Ramp Length LT (in)	65	N/A	Ramp Length RT (in)	66				
	Yes	Ramp Width LT (in)	90	Yes	Ramp Width RT (in)	90				
	Yes	Ramp Run Slope LT (%)	5.5	Yes	Ramp Run Slope RT (%)	5.7				
	Yes	Ramp Cross Slope LT (%)	1.5	Yes	Ramp Cross Slope RT (%)	0.1				
	N/A	Landing Present	Yes	Yes	DWS Provided	Yes				
	N/A	Landing Length (in)	90	Yes	DWS Contrast	Yes				
	Yes	Landing Width (in)	48	Yes	DWS Length (in)	36				
	Yes	Landing Run Slope (%)	0.1	Yes	DWS Full Width	Yes				
	Yes	Landing Cross Slope (%)	0.6		DWS Offset Type	Single				
	N/A	Landing Movement Obstructed?	No	Yes	DWS Offset Left (in)	0				
		Landing Movement Type	Curb	Yes	DWS Offset Right (in)	N/A				
	N/A	Landing Shared	No							
	N/A	Clear Space	Yes							
	N/A	Clear Space To Crosswalk (in)	48							
)	N/A	Marked Crosswalk 1	No	N/A	Marked Crosswalk 2	No

Crossing 1 Direction	SE		Crossing 2 Direction	NE				
2		Marked Crosswalk 1 Width (in)	N/A		Marked Crosswalk 2 Width (in)	N/A				
ı	N/A	Ramp Inside Crosswalk 1	N/A	N/A	Ramp Inside Crosswalk 2	N/A				
г		Crossing 1 Slope (%)	2.1		Crossing 2 Slope (%)	2.6				
ı		Crossing 1 Cross Slope (%)	0.2		Crossing 2 Cross Slope (%)	1.6				
	Yes	Gutter Ponding	No	Yes	Curb Slope	6.7				
	Yes	Gutter Lip Height (in)	0		Road Run Slope (%)	0.4				
	Yes	Gutter Run Slope (%)	3.8		Road Cross Slope (%)	4.2

-	Yes	Gutter Cross Slope (%)	0.6	Yes	Perpendicular Joint Present	Yes				
1	Yes	Overall Surface Condition Accep	ptable							
		Cross Gutter Present?	No		Spandrel Present?	No				
`		Replace Cross Gutter?	N/A	J	Replace Spandrel?	N/A
