# Access Compliance Report Public Rights-of-Way (Curb Ramps)

| Main Street: <b>NARROW_CANYON_RD</b> | | Cross Street: <b>N/A</b> | | Location: <b>E</b> |
| ADA ID: <b>RPRK211202121954</b> | Ramp Type: <b>Type 4 - Parallel</b> | Initial Pass/Fail: <b>Pass</b> | Overall Compliance: <b>No</b> | Severity Score: <b>25</b> |

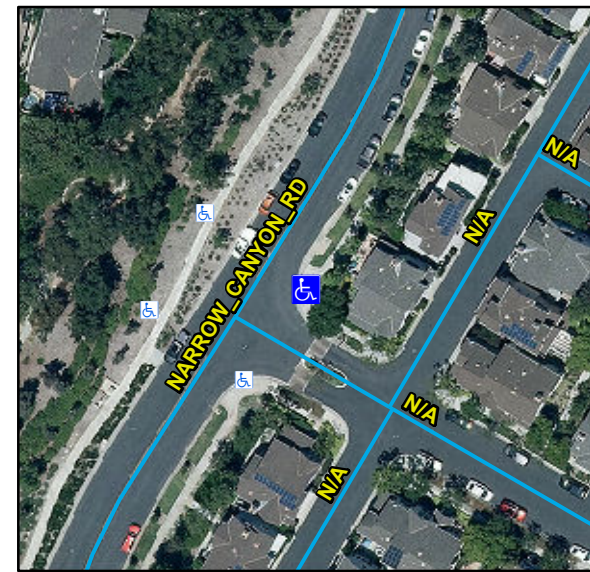
| Compliance | Description | Data | Compliance | Description | Data |
|---|---|---|---|---|---|
| <b>No</b> | Landing Width (in) | <b>N/A</b> | <b>N/A</b> | DWS Length (in) | <b>N/A</b> |
| <b>No</b> | Landing Run Slope (%) | <b>N/A</b> | <b>N/A</b> | DWS Full Width | <b>N/A</b> |
| <b>No</b> | Landing Cross Slope (%) | <b>N/A</b> | | DWS Offset Type | <b>N/A</b> |
| <b>No</b> | Gutter Run Slope (%) | <b>7.6</b> | | Road Cross Slope (%) | <b>0.9</b> |
| <b>No</b> | Gutter Cross Slope (%) | <b>3.8</b> | <b>No</b> | Perpendicular Joint Present | <b>No</b> |

**Remove & Replace Curb Ramp With Two New Directional Ramps or Equivalent. Remove & Replace Gutter.**

**R204.3, R304.2.1, R304.2.2-Perp, R304.3.2-Para, R304.5.3, R305, R304.5.4, STD 1115**
