# Access Compliance Report Public Rights-of-Way (Curb Ramps)

Main Street: YELLOWTAIL\_DR Cross Street: ST\_CLOUD\_DR Location: SW

ADA ID: RPRK211206135458 Ramp Type: Type 4 - Parallel Initial Pass/Fail: Fail Overall Compliance: No Severity Score: 2

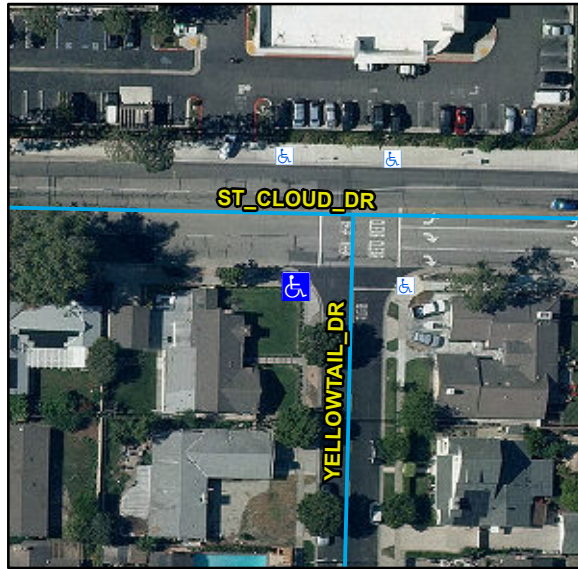
| Compliance | Description | Data | Compliance | Description | Data |
|---|---|---|---|---|---|
| Yes | Ramp Cross Slope LT (%) | 1.1 | No | Ramp Cross Slope RT (%) | 5 |

Remove & Replace Curb Ramp With Two New Directional Ramps or Equivalent.

R204.3, R304.5.3, STD 1115

Total Cost: \$ 4000
