# Access Compliance Report Public Rights-of-Way (Curb Ramps)

Main Street: KEITHLEY\_DR Cross Street: MARTHA\_ANN\_DR Location: NE

ADA ID: RPRK211207115058 Ramp Type: Type 1 - Perpendicular Diagonal Initial Pass/Fail: Pass Overall Compliance: No Severity Score: 6

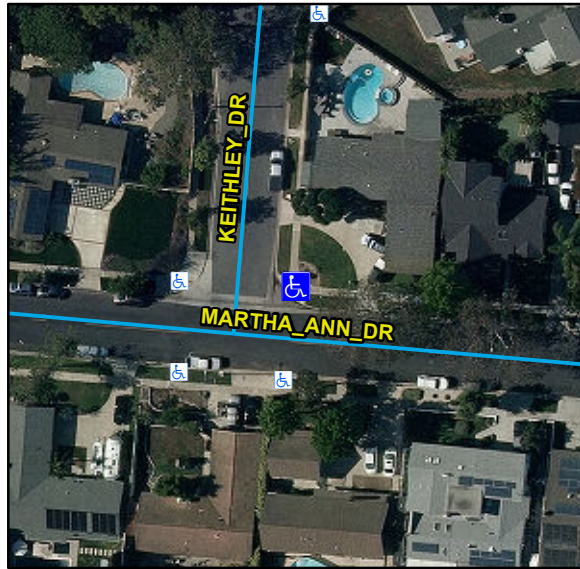
| Compliance | Description | Data | Compliance | Description | Data |
|---|---|---|---|---|---|
| No | Landing Cross Slope (%) | 2.1 | Yes | DWS Provided | Yes |
| No | Gutter Ponding | Yes | Yes | Curb Slope | 0.9 |
| No | Gutter Cross Slope (%) | 2.6 | | | |

Remove & Replace Landing. Remove & Replace Gutter.

R304.2.1, R304.5.3, R302.7, STD 1115
