Access Compliance Report Public Rights-of-Way (Curb Ramps)

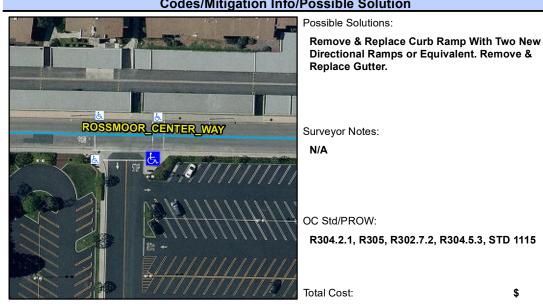
Main Street: ROSSMOOR CENTER WAY **Cross Street: N/A** Location: SE

Field Measurements/Component Compliance									
	Com	Compliance Description		Compliance Description		Data			
N	N/A	Ramp Length (in)	78	N/A	Flare Type LT				
	Yes	Ramp Width (in)	48			Sloped			
	Yes	Ramp Run Slope (%)	5.5	Yes	Flare Slope LT (%)	8.1			
	Yes	Ramp Cross Slope (%)	0.1	N/A	Flare Traversable LT	Yes			
	N/A	Landing Present	Yes	N/A	Flare Type RT				
	N/A	Landing Length (in)	47			Sloped			
	Yes	Landing Width (in)	48	N/A	Flare Slope RT (%)	15.1			
	Yes	Landing Run Slope (%)	1.7	N/A	Flare Traversable RT	No			
	Yes	Landing Cross Slope (%)	0.5	No	DWS Provided	No			
	N/A	Landing Movement Obstructed?	No	N/A	DWS Contrast	N/A			
		Landing Movement Type	N/A	N/A	DWS Length (in)	N/A			
1	N/A	Landing Shared	No	N/A	DWS Full Width	N/A			
	Yes	Clear Space	Yes	N/A	DWS Offset Left (in)	N/A			
	Yes	Clear Space To Crosswalk (in)	48	N/A	DWS Offset Right (in)	N/A			
6412	N/A	Marked Crosswalk 1	Yes	N/A	Marked Crosswalk 2	Yes

Ramp Type:Type 1 - Perpendicular Diagonal Initial Pass/Fail: Pass ADA ID: RPRK211208114951 **Overall Compliance: No Severity Score:** 14
