# Access Compliance Report Public Rights-of-Way (Curb Ramps)

Main Street: N/A Cross Street: ROSSMOOR\_CENTER\_WAY Location: S

ADA ID: RPRK211208115408 Ramp Type: Type 4 - Parallel Initial Pass/Fail: Fail Overall Compliance: No Severity Score: 2

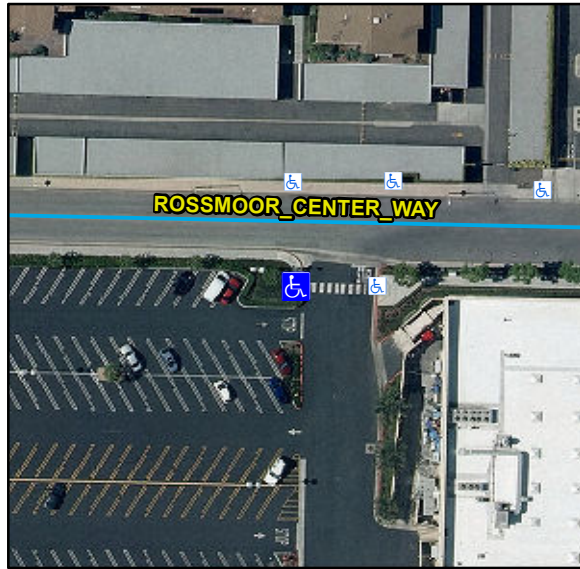
| Compliance | Description | Data | Compliance | Description | Data |
|---|---|---|---|---|---|
| N/A | Ramp Cross Slope LT (%) | -9999 | No | Ramp Cross Slope RT (%) | 3.7 |

**Remove & Replace Entire Ramp.**

**R304.5.3, STD 1115**

Total Cost: \$ 2000
