# Access Compliance Report Public Rights-of-Way (Curb Ramps)

Main Street: N/A Cross Street: ROSSMOOR\_CENTER\_WAY Location: SW

ADA ID: RPRK211208120101 Ramp Type: Type 1 - Perpendicular Initial Pass/Fail: Pass Overall Compliance: No Severity Score: 0

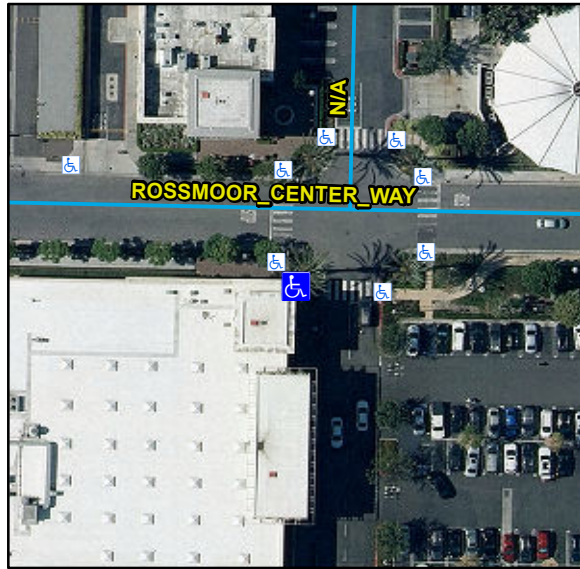
| Compliance | Description | Data | Compliance | Description | Data |
|---|---|---|---|---|---|
| No | Landing Run Slope (%) | 3.6 | N/A | Flare Traversable RT | N/A |
| No | Landing Cross Slope (%) | 3 | Yes | DWS Provided | Yes |

Remove & Replace Landing.

R304.2.2-Perp, R304.3.2-Para, R304.5.3, STD 1115

Total Cost: \$ 531
