# Access Compliance Report Public Rights-of-Way (Curb Ramps)

Main Street: HARRISBURG\_RD Cross Street: WEATHERBY\_RD Location: NW

ADA ID: RPRK211215115014 Ramp Type: Type 1 - Perpendicular Diagonal Initial Pass/Fail: Pass Overall Compliance: No Severity Score: 0

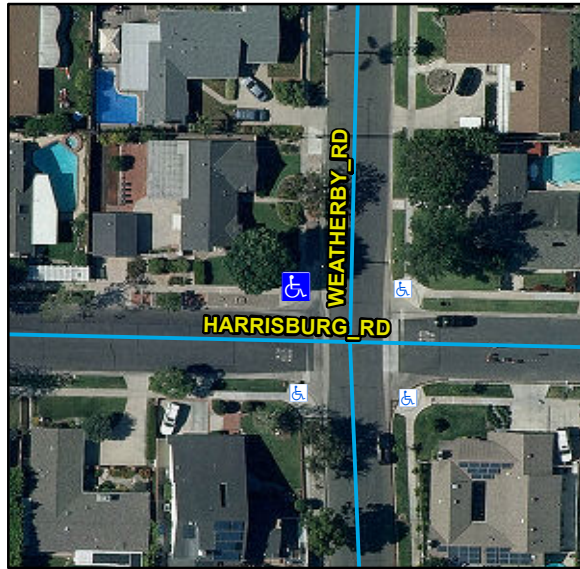
| Compliance | Description | Data | Compliance | Description | Data |
|---|---|---|---|---|---|
| No | Landing Run Slope (%) | 3.6 | N/A | Flare Traversable RT | No |
| N/A | Landing Movement Obstructed? | Yes | Yes | DWS Contrast | Yes |
| | Landing Movement Type | Bushes | Yes | DWS Length (in) | 36 |
| Yes | Gutter Ponding | No | No | Curb Slope | 9.3 |

Remove & Replace Curb Ramp With Two New Directional Ramps or Equivalent.
