# Access Compliance Report Public Rights-of-Way (Curb Ramps)

| Main Street: SHAKESPEARE_DR | | Cross Street: MONTECITO_RD | | Location: | S |
| ADA ID: RPRK211215130141 | Ramp Type: Type 4 - Parallel | Initial Pass/Fail: Pass | Overall Compliance: No | Severity Score: | 16 |

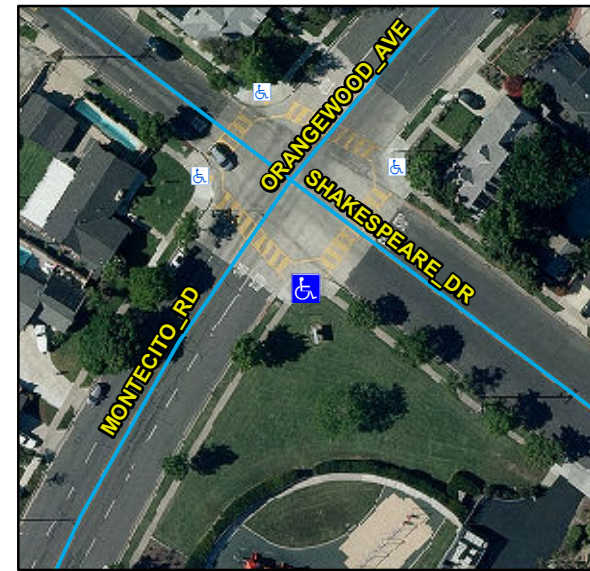
| Compliance | Description | Data | Compliance | Description | Data |
|---|---|---|---|---|---|
| No | Ramp Cross Slope LT (%) | 5.2 | No | Ramp Cross Slope RT (%) | 4.5 |
| No | Landing Run Slope (%) | 2.5 | Yes | DWS Full Width | Yes |
| No | Gutter Cross Slope (%) | 3.1 | Yes | Perpendicular Joint Present | Yes |

**Remove & Replace Curb Ramp With Two New Directional Ramps or Equivalent. Remove & Replace Gutter.**

**R304.5.3, R304.2.2-Perp, R304.3.2-Para, STD 1115**

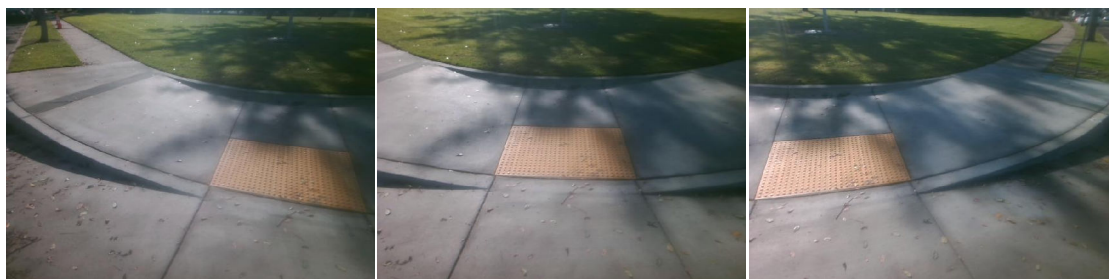
| Compliance | Description | Data | Compliance | Description | Data |
|---|---|---|---|---|---|
| N/A | Ramp Length LT (in) | 94 | N/A | Ramp Length RT (in) | 114 |
| Yes | Ramp Width LT (in) | 97 | Yes | Ramp Width RT (in) | 98 |
| Yes | Ramp Run Slope LT (%) | 7.2 | Yes | Ramp Run Slope RT (%) | 4.3 |
