# Access Compliance Report Public Rights-of-Way (Curb Ramps)

Main Street: SHAKESPEARE\_DR Cross Street: ROSSMOOR\_WAY Location: NW

ADA ID: RPRK211215132223 Ramp Type: Type 4 - Parallel Initial Pass/Fail: Fail Overall Compliance: No Severity Score: 30

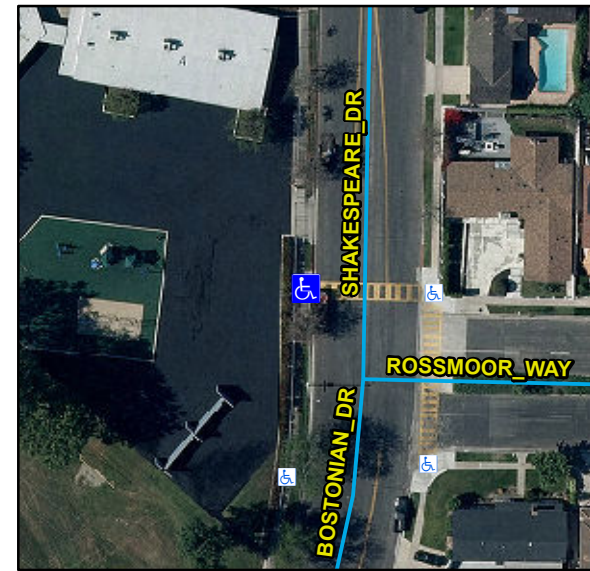
| Compliance | Description | Data | Compliance | Description | Data |
|---|---|---|---|---|---|
| No | Ramp Cross Slope LT (%) | 7.4 | No | Ramp Cross Slope RT (%) | 5.1 |

Possible Solutions:

Remove & Replace Entire Ramp.

R304.5.3, STD 1115

Total Cost: \$ 2000
