# Access Compliance Report Public Rights-of-Way (Curb Ramps)

Main Street: HUNTLEY\_DR Cross Street: SHAKESPEARE\_DR Location: S

ADA ID: RPRK211215135826 Ramp Type: Type 1 - Perpendicular Diagonal Initial Pass/Fail: Pass Overall Compliance: No Severity Score: 10

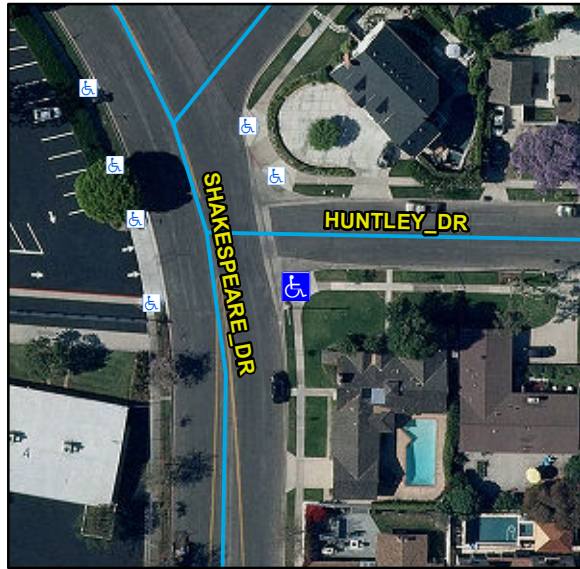
| Compliance | Description | Data | Compliance | Description | Data |
|---|---|---|---|---|---|
| Yes | Landing Cross Slope (%) | 0.1 | No | DWS Provided | No |

**Remove & Replace Curb Ramp With Two New Directional Ramps or Equivalent.**

**R204.3, R305, STD 1115**
