# Access Compliance Report Public Rights-of-Way (Curb Ramps)

Main Street: SHAKESPEARE\_DR Cross Street: HUNTLEY\_DR Location: NE

ADA ID: RPRK211215140159 Ramp Type: Type 1 - Perpendicular Diagonal Initial Pass/Fail: Pass Overall Compliance: No Severity Score: 10

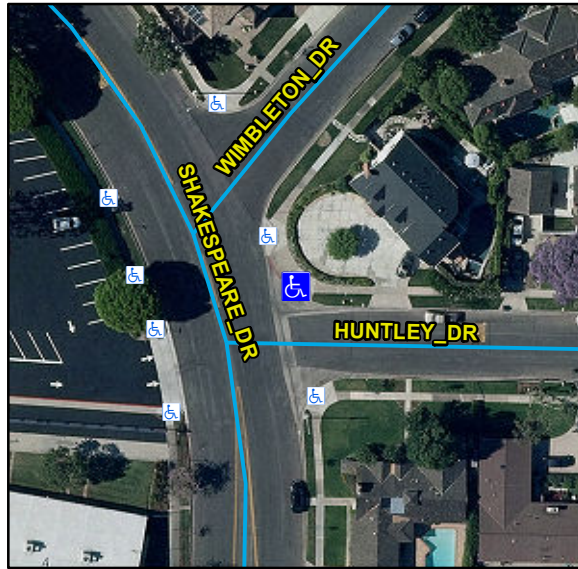
| Compliance | Description | Data | Compliance | Description | Data |
|---|---|---|---|---|---|
| No | Landing Run Slope (%) | 3.7 | N/A | Flare Traversable RT | No |
| Yes | Landing Cross Slope (%) | 1.4 | No | DWS Provided | No |

Remove & Replace Curb Ramp With Two New Directional Ramps or Equivalent.
