# Access Compliance Report Public Rights-of-Way (Curb Ramps)

Main Street: SALMON\_DR Cross Street: MARTHA\_ANN\_DR Location: SE

ADA ID: RPRK211216112052 Ramp Type: Type 1 - Perpendicular Diagonal Initial Pass/Fail: Pass Overall Compliance: No Severity Score: 20

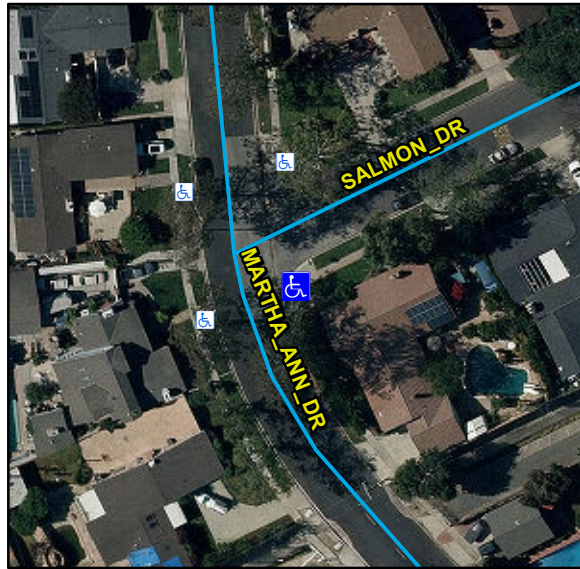
| Compliance | Description | Data | Compliance | Description | Data |
|---|---|---|---|---|---|
| No | Landing Width (in) | N/A | N/A | Flare Slope RT (%) | 7.2 |
| No | Landing Run Slope (%) | N/A | N/A | Flare Traversable RT | No |
| No | Landing Cross Slope (%) | N/A | No | DWS Provided | No |
| No | Gutter Ponding | Yes | No | Curb Slope | 8.7 |

Remove & Replace Curb Ramp With Two New Directional Ramps or Equivalent.
