# Access Compliance Report Public Rights-of-Way (Curb Ramps)

Main Street: ACECA\_DR Cross Street: NEWBURY\_RD Location: NW

ADA ID: RPRK211216133241 Ramp Type: Type 1 - Perpendicular Diagonal Initial Pass/Fail: Pass Overall Compliance: No Severity Score: 10

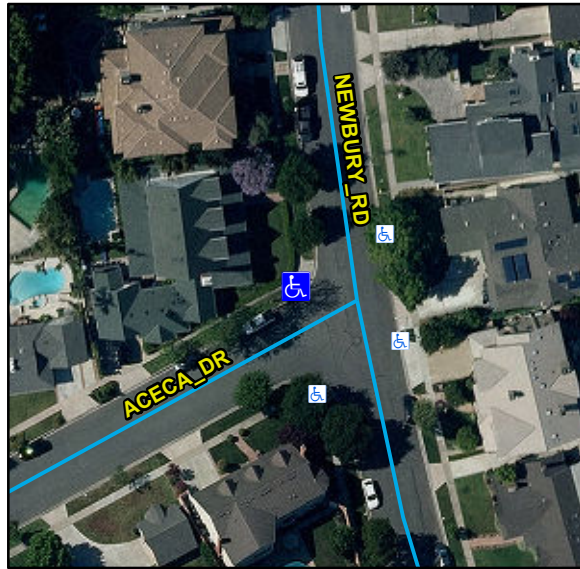
| Compliance | Description | Data | Compliance | Description | Data |
|---|---|---|---|---|---|
| No | Landing Run Slope (%) | 2.7 | N/A | Flare Traversable RT | No |
| No | Gutter Ponding | Yes | Yes | Curb Slope | 1.7 |
| No | Gutter Run Slope (%) | 7.2 | | Road Cross Slope (%) | 7.5 |

Remove & Replace Landing. Remove & Replace Gutter.
