# Access Compliance Report Public Rights-of-Way (Curb Ramps)

Main Street: HUNTLEY\_DR Cross Street: WEATHERBY\_RD Location: NW

ADA ID: RPRK211217123057 Ramp Type: Type 1 - Perpendicular Diagonal Initial Pass/Fail: Pass Overall Compliance: No Severity Score: 6

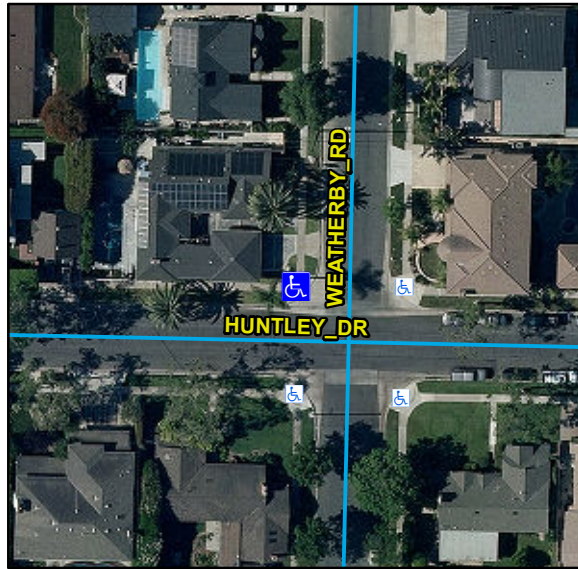
| Compliance | Description | Data | Compliance | Description | Data |
|---|---|---|---|---|---|
| No | Landing Run Slope (%) | 3.2 | N/A | Flare Traversable RT | No |
| No | Gutter Ponding | Yes | Yes | Curb Slope | 3.7 |
| No | Gutter Run Slope (%) | 5.7 | | Road Cross Slope (%) | 0.2 |

Remove & Replace Landing. Remove & Replace Gutter.
