# Access Compliance Report

## Public Rights-of-Way

### (Curb Ramps)

Main Street: LOS\_ALAMITOS\_BLVDCross Street: ROSSMOOR\_WAYLocation: NE

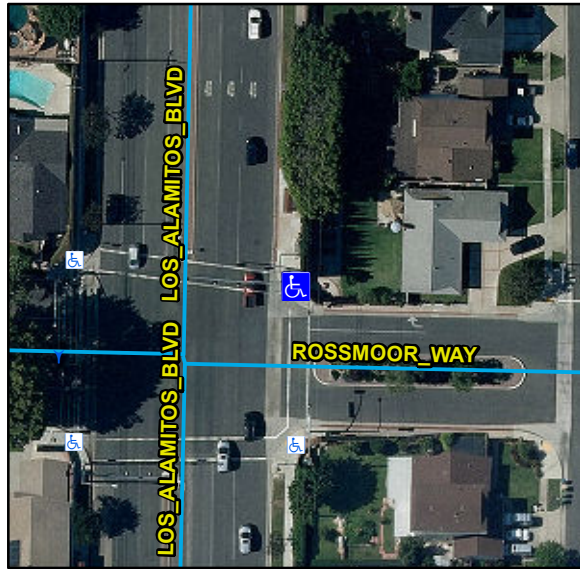
ADA ID: RPRK211217125324Ramp Type:Type 1 - Perpendicular Diagonal Initial Pass/Fail: PassOverall Compliance: NoSeverity Score: 6

| Compliance | Description | Data | Compliance | Description | Data |
|---|---|---|---|---|---|
| Yes | Gutter Ponding | No | No | Curb Slope | 7.3 |

Remove & Replace Curb Ramp With Two New Directional Ramps or Equivalent.

R304.2.2, R304.2.1, STD 1115
