# Access Compliance Report Public Rights-of-Way (Curb Ramps)

Main Street: ROSSMOOR\_WAY Cross Street: WEATHERBY\_RD Location: NW

ADA ID: RPRK211217131734 Ramp Type: Type 1 - Perpendicular Diagonal Initial Pass/Fail: Pass Overall Compliance: No Severity Score: 9

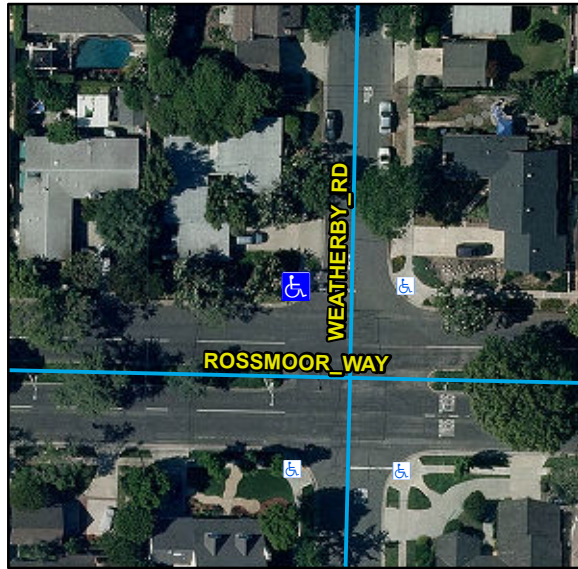
| Compliance | Description | Data | Compliance | Description | Data |
|---|---|---|---|---|---|
| No | Gutter Run Slope (%) | 6.3 | | Road Cross Slope (%) | 5.8 |

Remove & Replace Landing. Remove & Replace Gutter.

R304.2.1, R304.5.4, STD 1115
