# Access Compliance Report Public Rights-of-Way (Curb Ramps)

Main Street: WOODSTOCK\_RD Cross Street: CHAUCER\_RD Location: SE

ADA ID: RPRK211220115206 Ramp Type: Type 4 - Parallel Initial Pass/Fail: Pass Overall Compliance: No Severity Score: 0

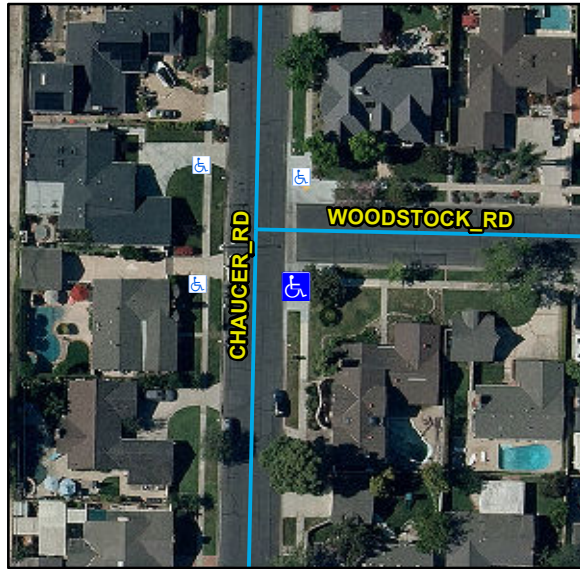
Gutter Ponding Observed.

| Compliance | Description | Data | Compliance | Description | Data |
|---|---|---|---|---|---|
| No | Gutter Ponding | Yes | Yes | Curb Slope | 1.3 |

R302.7, STD 1115

Total Cost: \$ 252
