# Access Compliance Report Public Rights-of-Way (Curb Ramps)

Main Street: MAIN\_WAY\_DR Cross Street: MARTHA\_ANN\_DR Location: S

ADA ID: RPRK211220133733 Ramp Type: Type 1 - Perpendicular Diagonal Initial Pass/Fail: Pass Overall Compliance: No Severity Score: 14

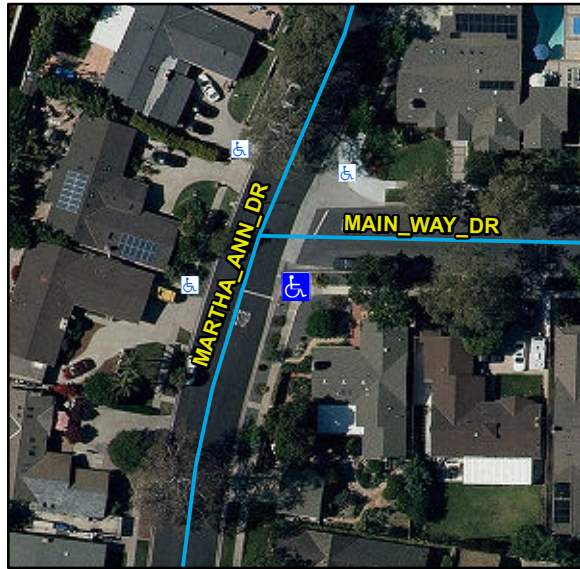
| Compliance | Description | Data | Compliance | Description | Data |
|---|---|---|---|---|---|
| No | Landing Run Slope (%) | 2.5 | N/A | Flare Traversable RT | No |
| Yes | Landing Cross Slope (%) | 0.7 | No | DWS Provided | No |

Remove & Replace Curb Ramp With Two New Directional Ramps or Equivalent.
