# Access Compliance Report Public Rights-of-Way (Curb Ramps)

Main Street: RANDALL\_ST Cross Street: RANDALL\_ST Location: SW

ADA ID: RPRK211222131226 Ramp Type: Type 4 - Parallel Initial Pass/Fail: Pass Overall Compliance: No Severity Score: 0

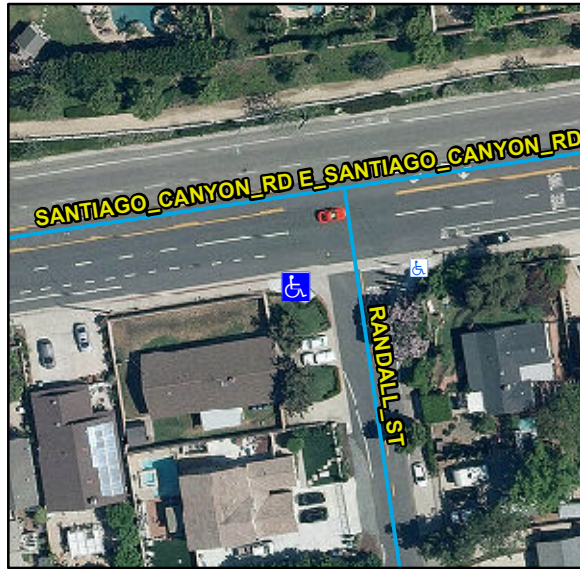
Gutter Ponding Observed.

| Compliance | Description | Data | Compliance | Description | Data |
|---|---|---|---|---|---|
| No | Gutter Ponding | Yes | Yes | Curb Slope | 4.3 |

OC Std/PROW:

R302.7, STD 1115
