# Access Compliance Report Public Rights-of-Way (Curb Ramps)

Main Street: **ESPLANADE\_ST** Cross Street: **E\_CHAPMAN\_AVE** Location: **SW**

ADA ID: **RPRK211223133429** Ramp Type: **Type 1 - Perpendicular Diagonal** Initial Pass/Fail: **Fail** Overall Compliance: **No** Severity Score: **0**

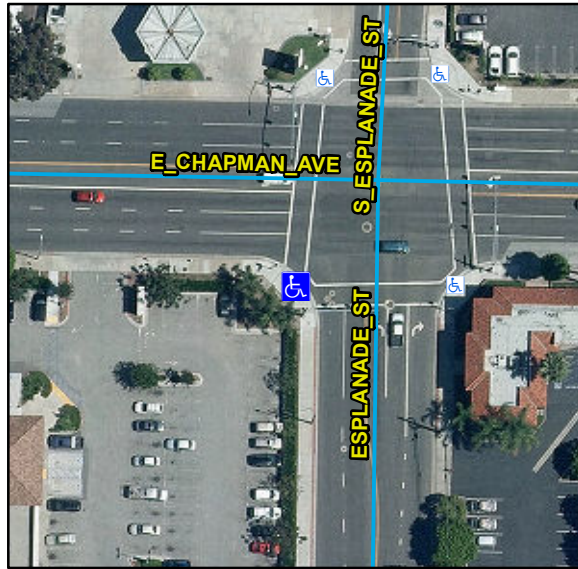
| Compliance | Description | Data | Compliance | Description | Data |
|---|---|---|---|---|---|
| N/A | Ramp Length (in) | 58 | N/A | Flare Type LT | |
| Yes | Ramp Width (in) | 48 | | | N/A |
| Yes | Ramp Run Slope (%) | 5.7 | N/A | Flare Slope LT (%) | N/A |
| Yes | Ramp Cross Slope (%) | 2.1 | N/A | Flare Traversable LT | N/A |
| N/A | Ramp Inside Crosswalk 1 | Yes | Yes | Ramp Inside Crosswalk 2 | Yes |

**Remove & Replace Curb Ramp With Two New Directional Ramps or Equivalent.**

**STD 1115**
