# Access Compliance Report Public Rights-of-Way (Curb Ramps)

Main Street: ETON\_PL Cross Street: ETON\_PL Location: SE

ADA ID: RPRK211229131409 Ramp Type: Type 4 - Parallel Initial Pass/Fail: Pass Overall Compliance: No Severity Score: 0

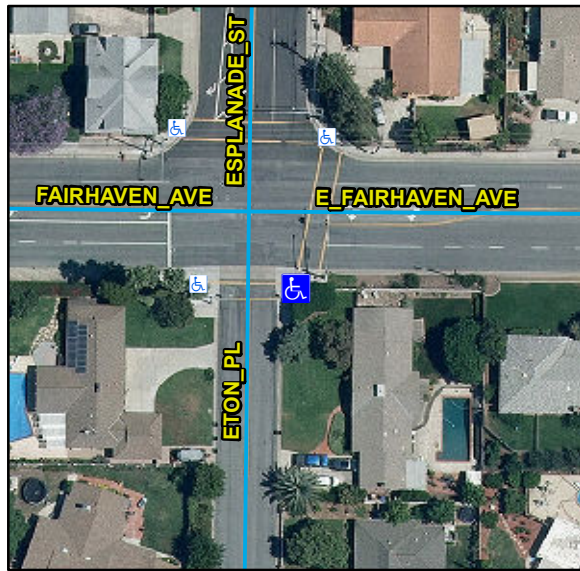
| Compliance | Description | Data | Compliance | Description | Data |
|---|---|---|---|---|---|
| N/A | Landing Movement Obstructed? | No | No | DWS Offset Left (in) | 3 |
| No | Ramp Inside Crosswalk 1 | No | No | Ramp Inside Crosswalk 2 | No |

Remove & Replace Detectable Warning System.  
Restripe Crosswalk.

R305.2, R207.1, STD 1115

\$ 4800
