# Access Compliance Report Public Rights-of-Way (Curb Ramps)

Main Street: E\_SKYLARK\_PL Cross Street: E\_SKYLARK\_PL Location: NE

ADA ID: RPRK220103114751 Ramp Type: Type 4 - Parallel Initial Pass/Fail: Pass Overall Compliance: No Severity Score: 0

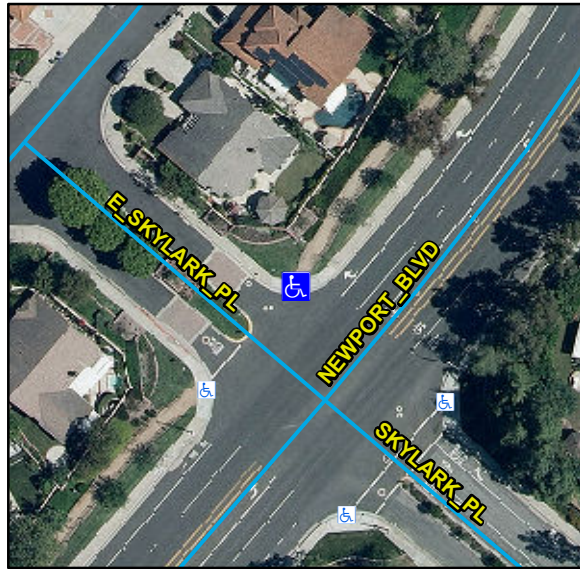
| Compliance | Description | Data | Compliance | Description | Data |
|---|---|---|---|---|---|
| No | Landing Cross Slope (%) | 3.5 | | DWS Offset Type | Single |
| No | Gutter Cross Slope (%) | 3.8 | Yes | Perpendicular Joint Present | Yes |

Remove & Replace Landing. Remove & Replace Gutter.

R304.5.3, STD 1115
