# Access Compliance Report Public Rights-of-Way (Curb Ramps)

Main Street: CHAPLET\_PL Cross Street: KENNETH\_DR Location: NW

ADA ID: RPRK220103154144 Ramp Type: Type 4 - Parallel Initial Pass/Fail: Pass Overall Compliance: No Severity Score: 0

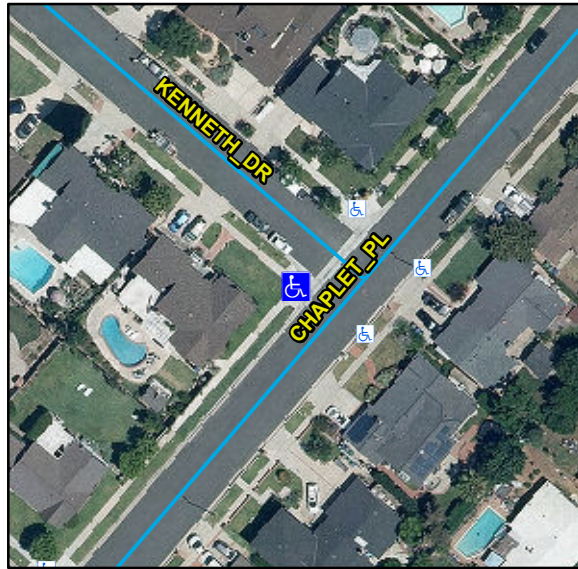
Gutter Ponding Observed.

| Compliance | Description | Data | Compliance | Description | Data |
|---|---|---|---|---|---|
| No | Gutter Ponding | Yes | Yes | Curb Slope | 3.2 |

R302.7, STD 1115

Total Cost: \$ 252
