# Access Compliance Report Public Rights-of-Way (Curb Ramps)

Main Street: TIFFANY\_PL Cross Street: WOODLAWN\_AVE Location: N

ADA ID: RPRK220107123626 Ramp Type: Type 1 - Perpendicular Diagonal Initial Pass/Fail: Pass Overall Compliance: No Severity Score: 0

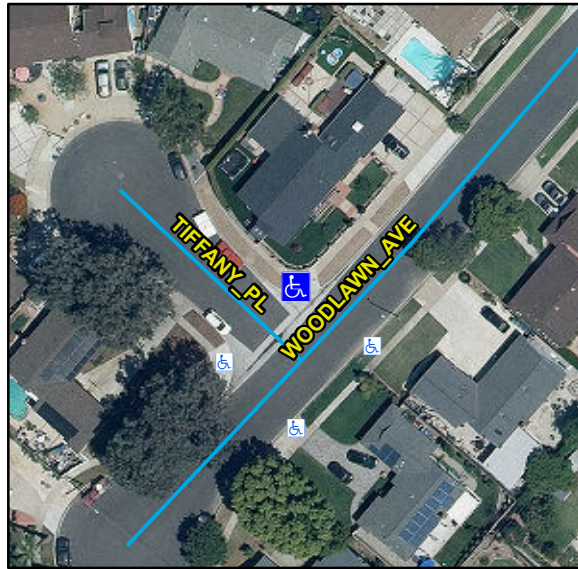
## Field Measurements/Component Compliance

| Compliance | Description | Data | Compliance | Description | Data |
|---|---|---|---|---|---|
| N/A | Landing Movement Obstructed? | Yes | Yes | DWS Contrast | Yes |
| | Landing Movement Type | Curb | Yes | DWS Length (in) | 36 |

Remove & Replace Landing.

R304.2.1, STD 1115

Total Cost: \$ 531
